## SUBJECT

### Bang & Olufsen Sound System: Loudspeaker Cover Rattles

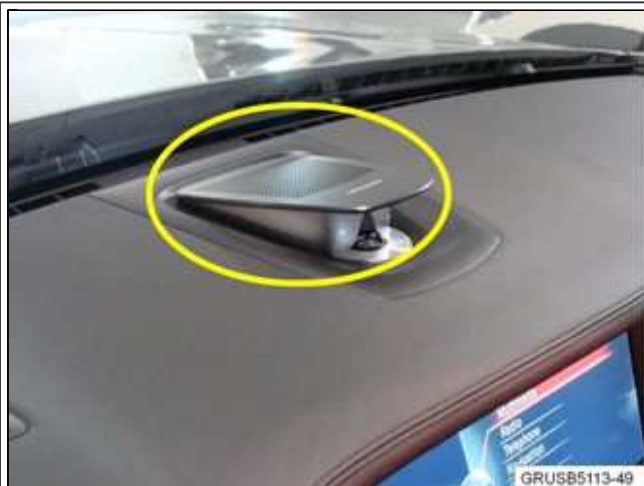
The top center loudspeaker cover rattles when driving on rough roads.

Poor loudspeaker cover fitment to the speaker assembly

1. Use ISTA Repair Instruction 65 13 052 to remove the loudspeaker cover from the speaker.
